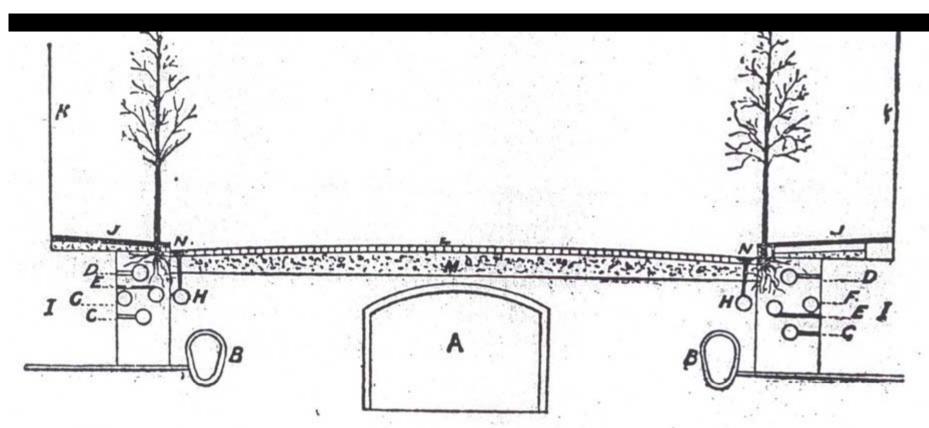
FIG. 52.—HINDRANCES TO STREET TREES.

(A section of Kingsway, London.)

Subway for trams.

B B Sewers.

C C Gas mains.

11D Water mains.

E E Electric cables.

F Telephone conduit.

Telegraph conduit. . G

HH Surface water drains.

II Cellars.

J J Asphalt path. K K Buildings.

L Wood paving.

M Concrete.

N N Gulleys.
